Earthquake Risk to Water Distribution Systems

Jonathan P. Stewart
Professor and Chair
UCLA Civil & Environmental Engineering

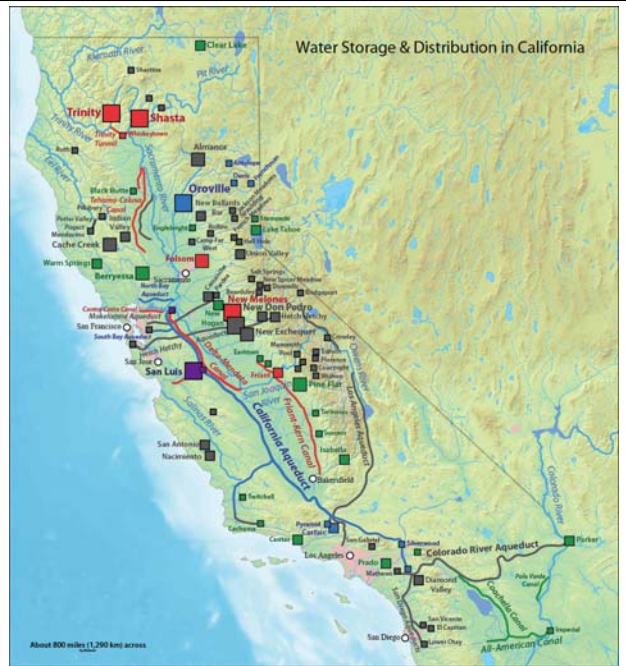
Three aqueducts supply southern California:

- LA Aqueduct
- Colorado R. Aqueduct
- California Aqueduct

All cross San Andreas fault

Temporary local supply south of fault

California Aqueduct:

- Intake in Delta
- 40% of supply, but impact is greater
- Greatest risk is local earthquakes in Delta region

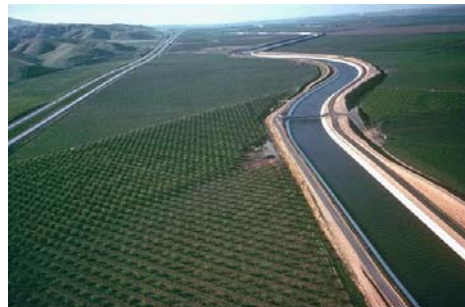
California Water Project

Requires fresh water at intake

Maintained in Delta waterways only by adequate outflow to push back the saline bay waters

For over 70 years, a fresh water Delta has been maintained by controlling the amount of outflow

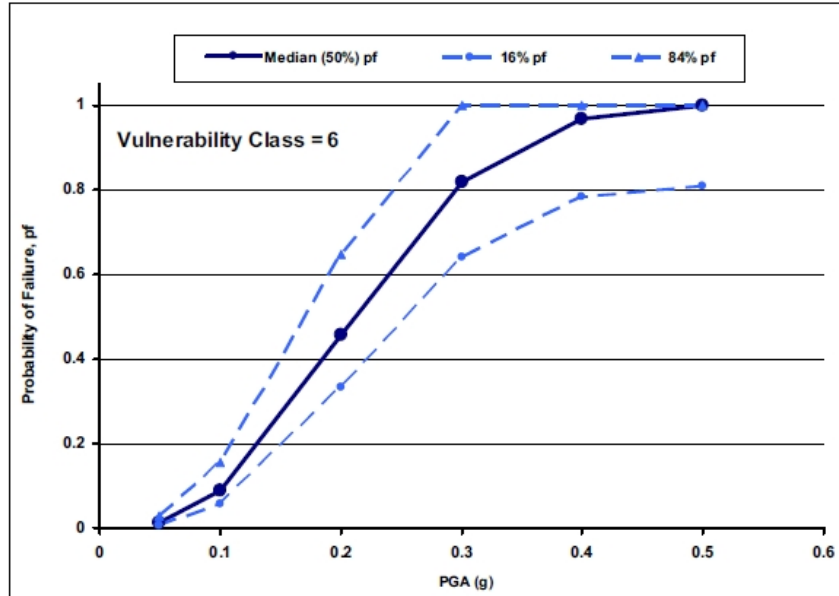
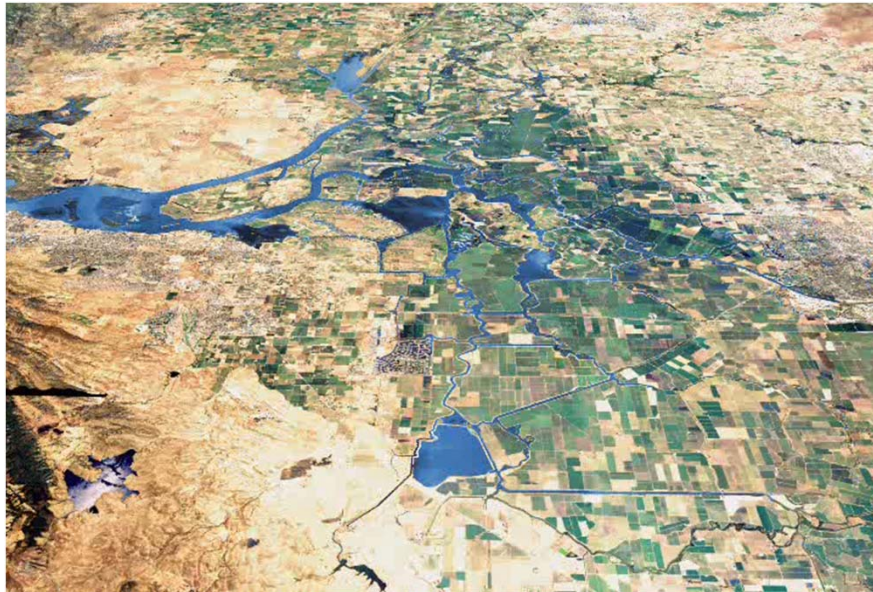
Seismic Hazard

Delta Risk Management Strategy, 2009
